March 24, 2022 Accident
Field Investigation Report
Free Fall
Icon Park, Orlando, Florida

Prepared for the Florida Department of Agriculture and Consumer
Services, Bureau of Fair Ride Inspections

Re: Field Investigation Report
File: Free Fall Icon Park, Orlando, Florida
Quest No.: 10623

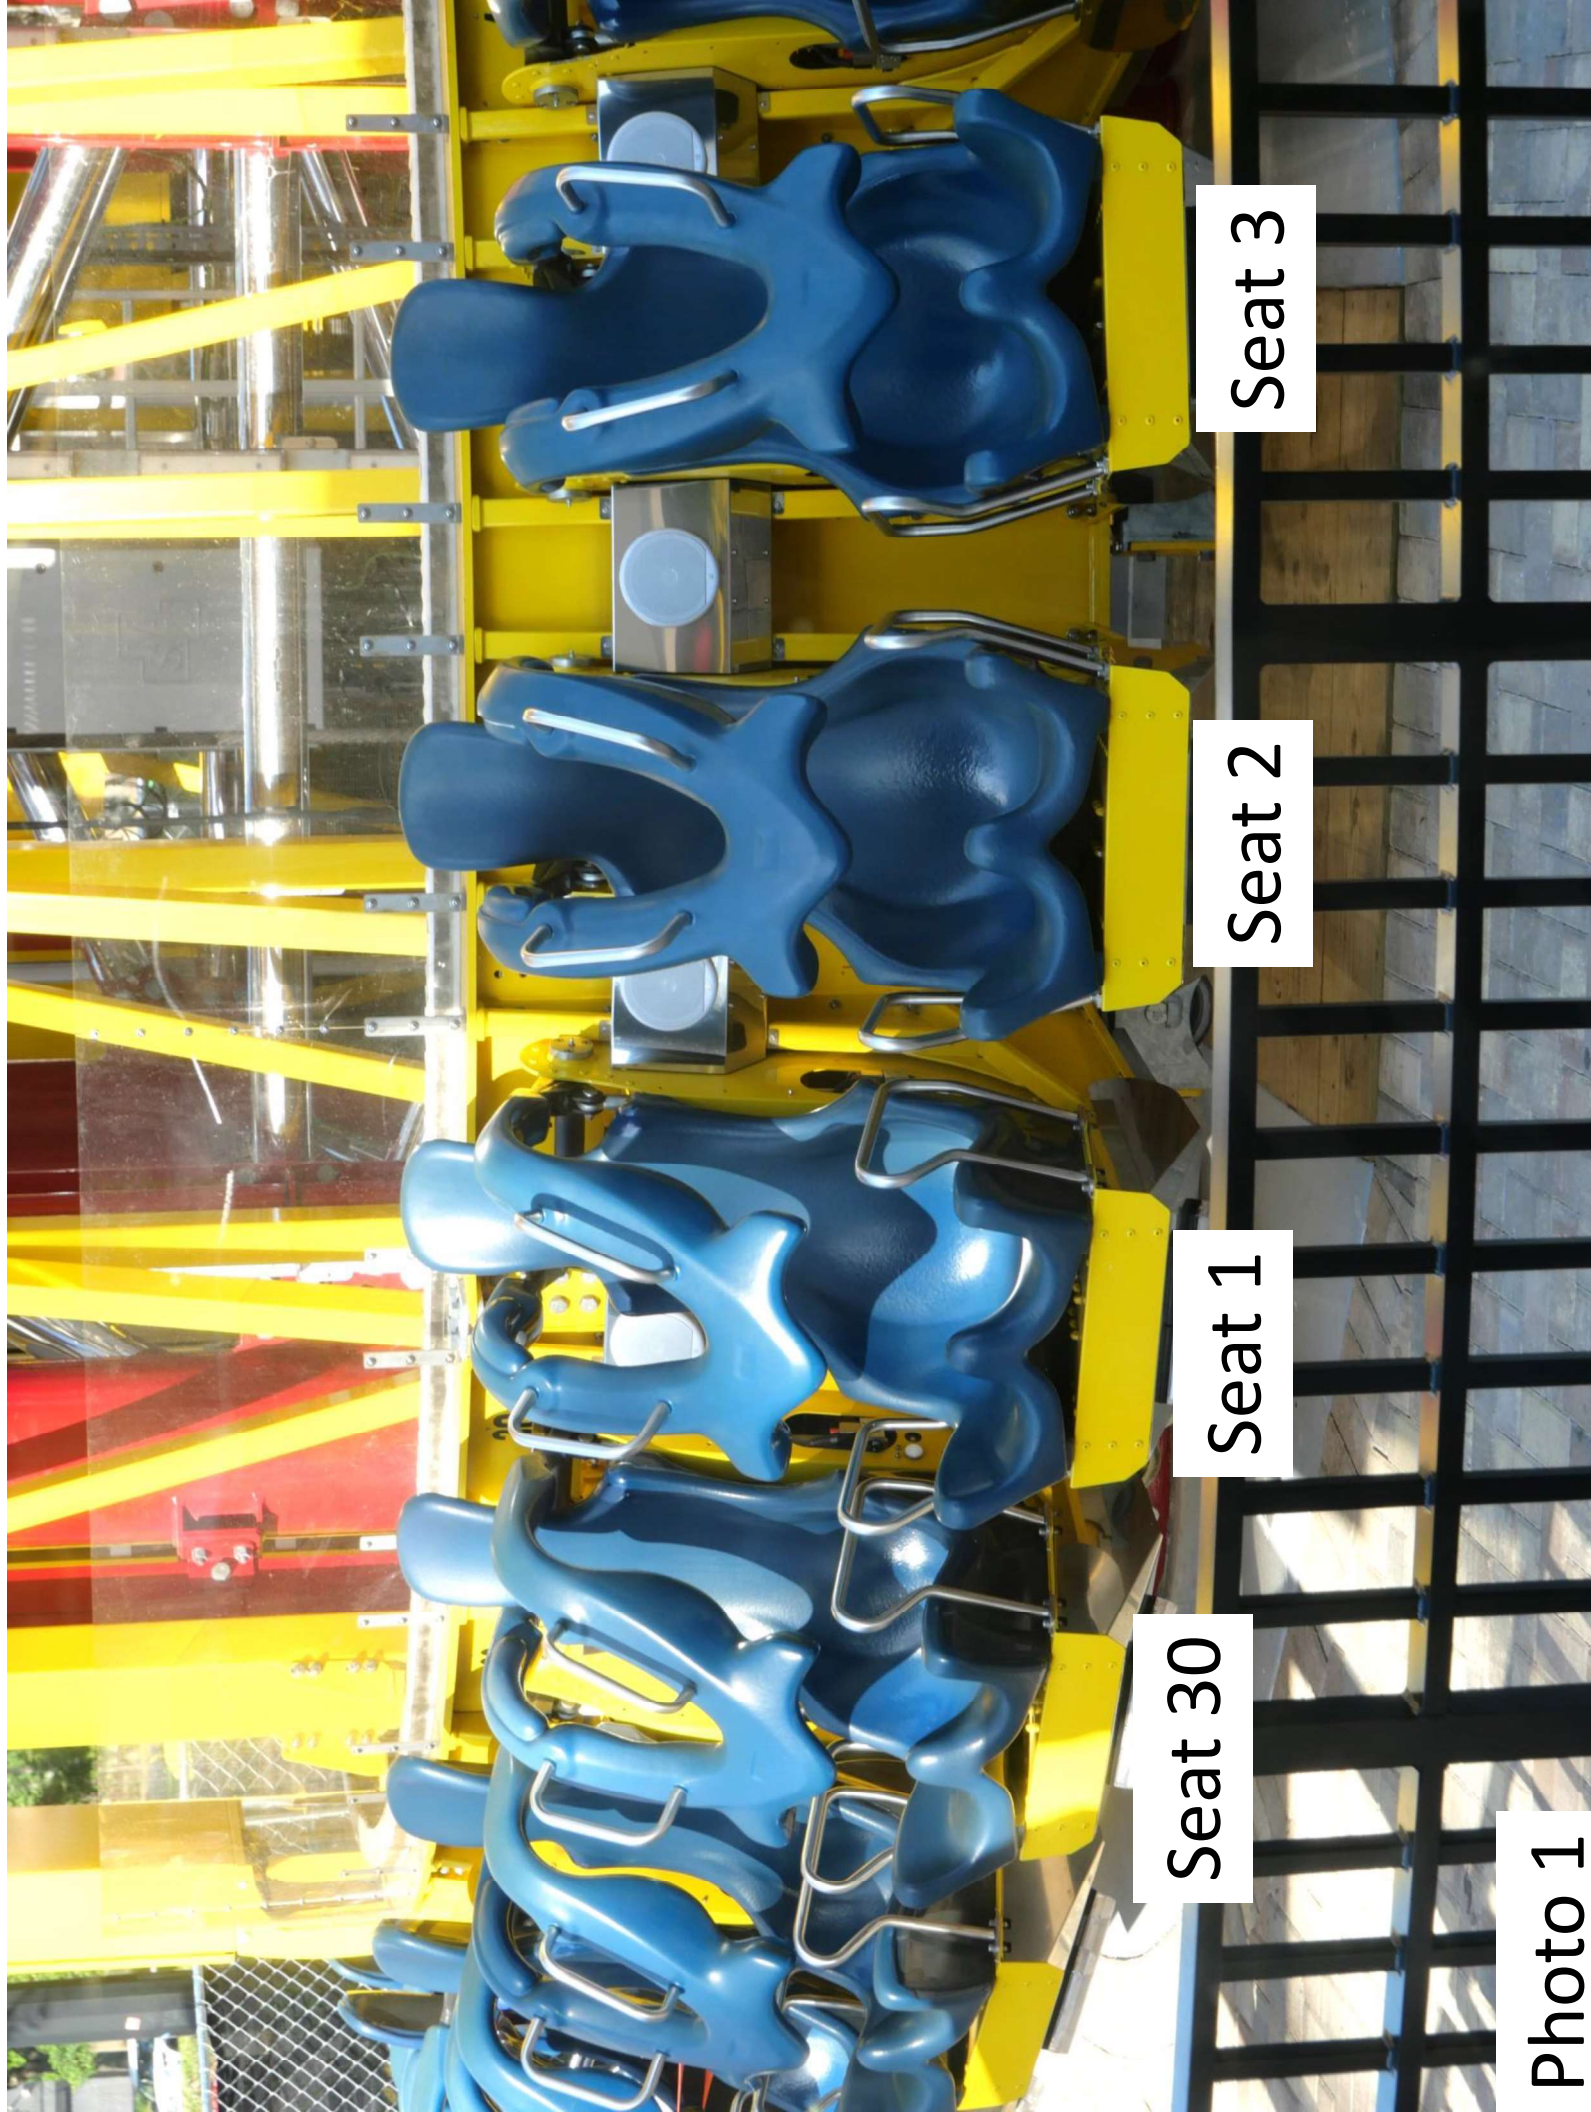
The physical and mechanical components of the ride did not reveal any evidence of physical or mechanical failure. All systems inspected or observed physically and mechanically functioned. The systems demonstrated no evidence of distortion or fracture type failures. Photo 1 shows an overview of Seats 30, 1, 2 and 3.

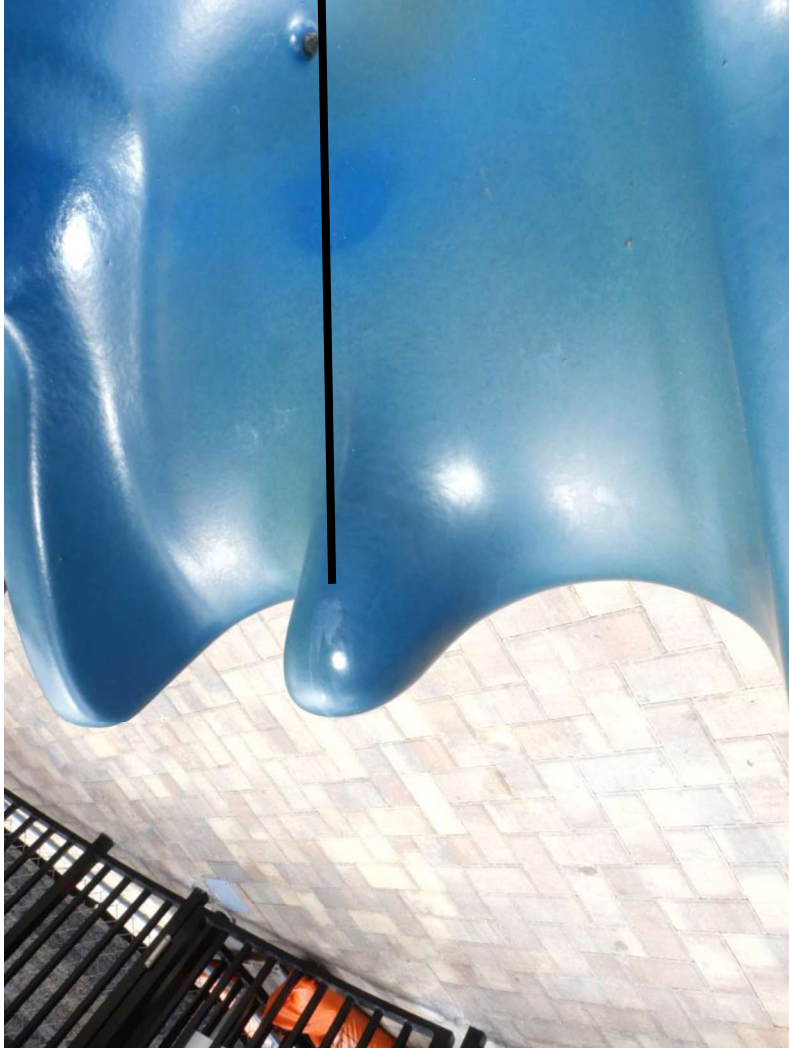
Photo 2

Seat 1, which had been occupied by Tyre Sampson, demonstrated accident-related evidence in the form of longitudinal striations on the seat base. The striations are consistent with video evidence that he slid out of the seat by sliding forward across the seat base. Specifically, the striations were located on the seat “horn” which is a raised section on the front edge of the seat base that fits between the rider’s legs and is part of the ride’s restraint system. To exit the seat, a rider would need to slide forward over this horn. Attached photos 2 and 3 show the seat and evidence.

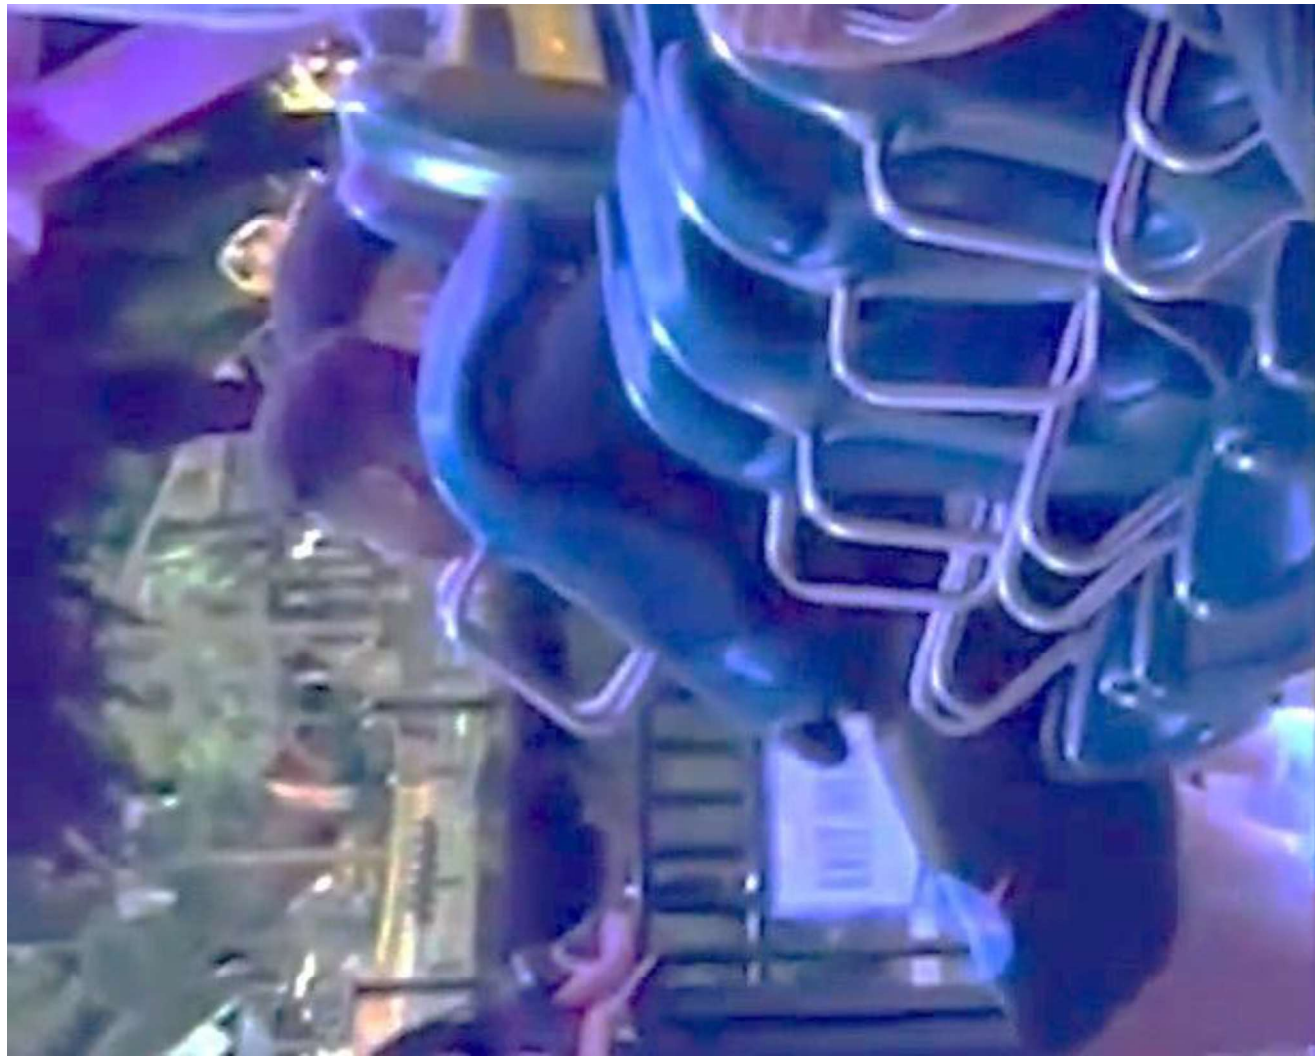
Photo 4

Video images show the position of the seat’s restraint “harness” on Tyre Sampson. The “harness” is one of the terms used in the ride’s Operations and Maintenance Manual to describe the device that lowers over the rider’s shoulders down onto their torso and lap area to complete the overall restraint system for the ride. During our field investigation we used image transparencies to replicate the accident harness position to the time of the accident. For reference we measured the minimum gap between the harness and the seat horn and will refer to that throughout this report as the “restraint opening.” The accident seat’s restraint opening was measured to be more than six inches but less than seven inches with a most likely value nearer seven inches. Attached photos 4 and 5 show the accident seat prior to the accident and an investigation comparative photograph with the opening at seven inches.

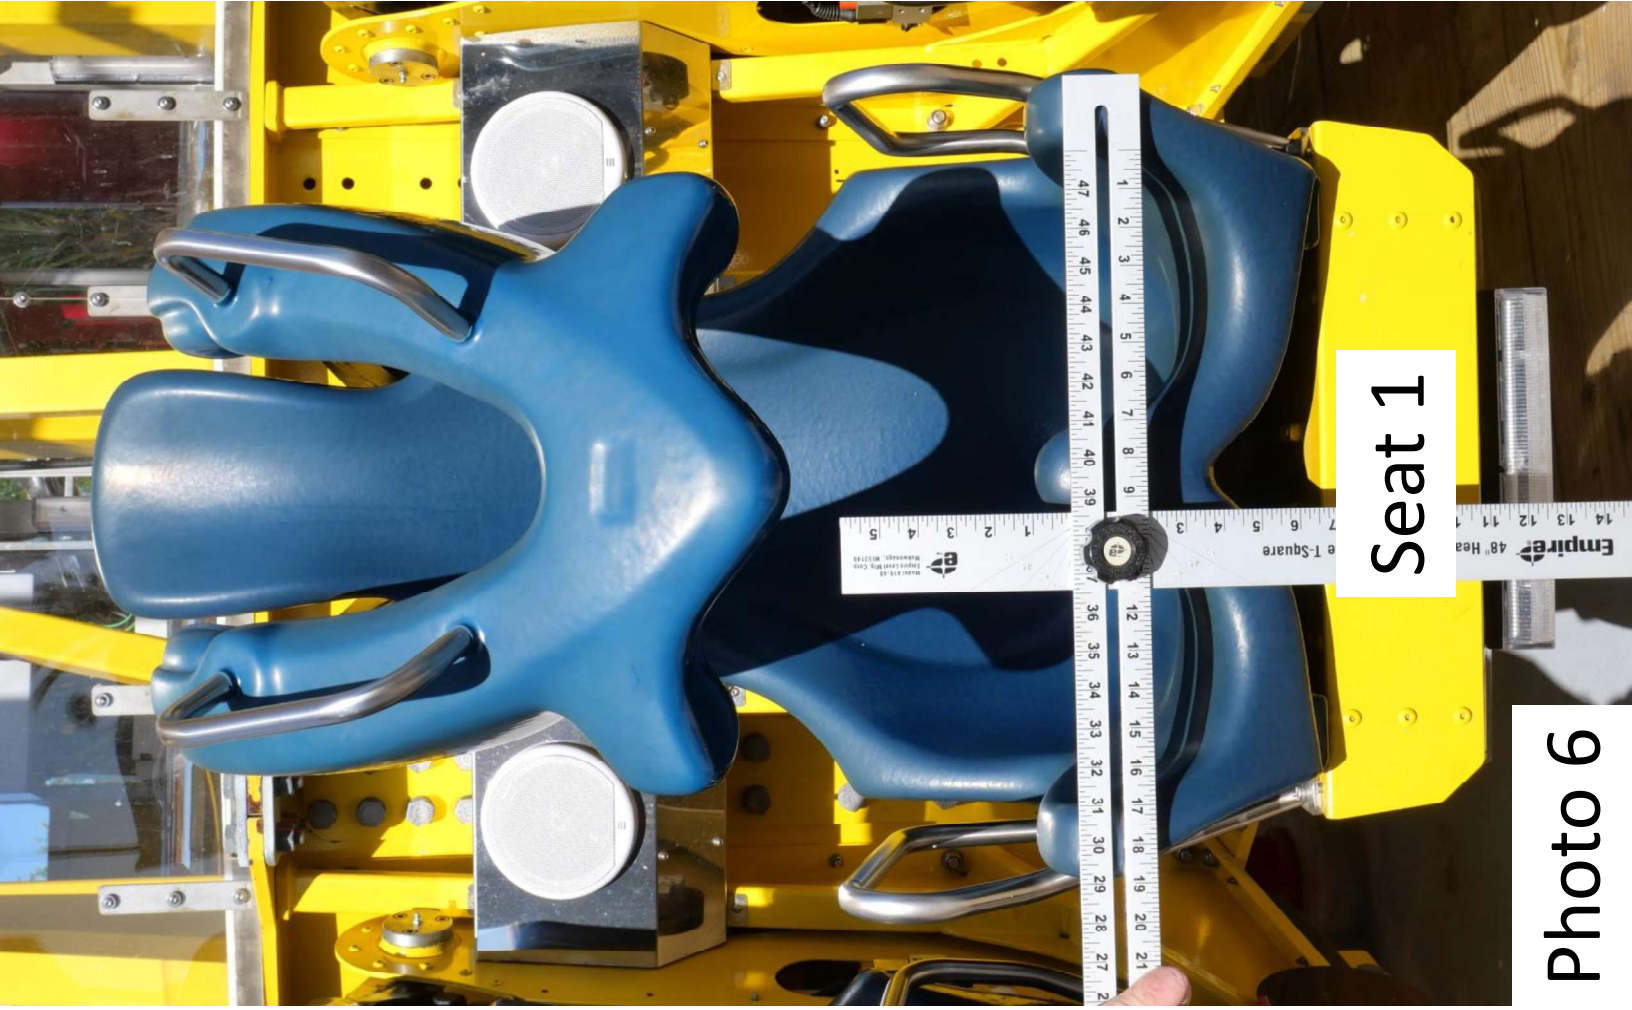
Photo 6

We will refer to both of these lights collectively as “safety lights.” Until the safety lights illuminated, the ride would not function. In an accident video, Seat 1’s seat mounted safety light was illuminated. At our inspection, we positioned all seats to the maximum restraint opening which illuminated each seat’s safety lights. The ride has 30 seats; however, one had previously been decommissioned and two had visibly larger openings than the remaining 27 seats. Measurements of the 27 seats revealed an average restraint opening 3.33 inches with a total range of 2.65 to 4.28 inches and is defined in this report as the “normal” restraint opening. The restraint opening for Seat 1 was 7.19 inches and Seat 2 was 6.51 inches. Attached photos 6 through 9 show comparisons between Seat 1 and Seat 22 which had and the average opening of 3.33 inches.

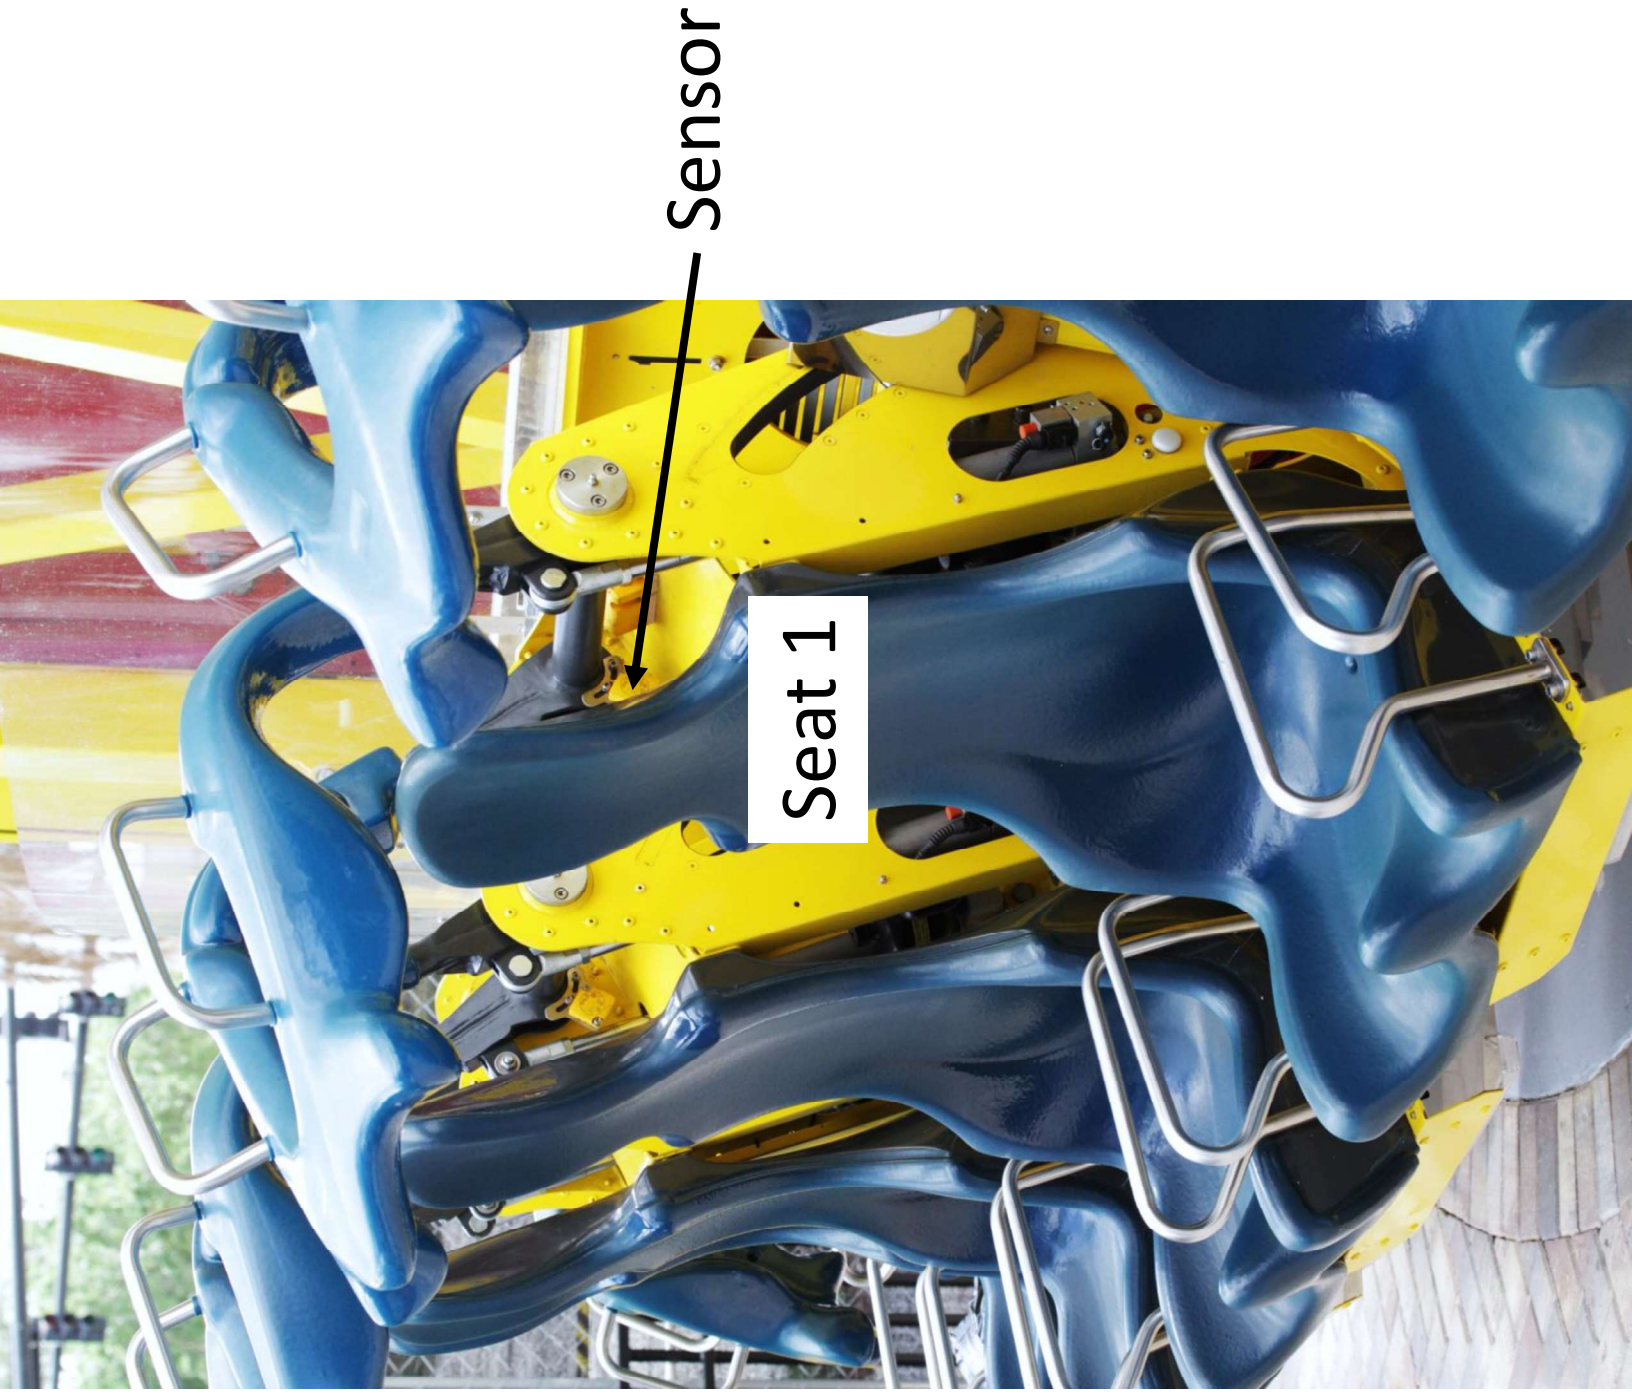
Photo 10

Each seat has a proximity sensor used to activate the safety lights when the harness is lowered to a preset location. Each proximity sensor is secured to the harness with a slotted plate that is adjustable and positioned by two socket head cap screws. The adjustment of the proximity sensor locations has a direct effect on the restraint opening gap. Inspection of the plates for Seats 1 and 2 revealed evidence that adjustments were made to their proximity sensor locations **after** the sensors were initially secured in place. On Seats 1 and 2, clear clamping marks from screw tightening exist on the plate that record the initial securement location of the proximity sensors. Geometric calculations reveal that the initial proximity sensor securement location for Seat 1 would have located the Seat 1 harness to near 3 inches, or a more closed location with a sensor and restraint opening similar to the unadjusted 27 seats. Photographs 10 through 12 show the Seat 1 plate location and clamping marks demonstrating the sensor was previously secured and then moved.

The evidence of adjustment after initial sensor securement was unique to Seats 1 and 2. Other seats did have light scrapes on the plates typical of fine tuning of the sensor location during ride set-up. But, only Seats 1 and 2 demonstrated the more distinctive clamping type marks which evidenced actual tightening of the screws onto the adjustment plate and then loosening and movement of the sensors to a new location.

Prior to the time of the accident, but subsequent to the initial setting, Seat 1's harness proximity sensor was manually loosened, adjusted, and tightened to allow a restraint opening of near 7 inches.

The cause of the subject accident was that Tyre Sampson was not properly secured in the seat primarily due to mis-adjustment of the harness proximity sensor. The mis-adjustment of the sensor allowed both safety lights to illuminate, improperly satisfying the ride's electronic safety mechanisms and allowing the ride to commence even though the ride was unsafe.

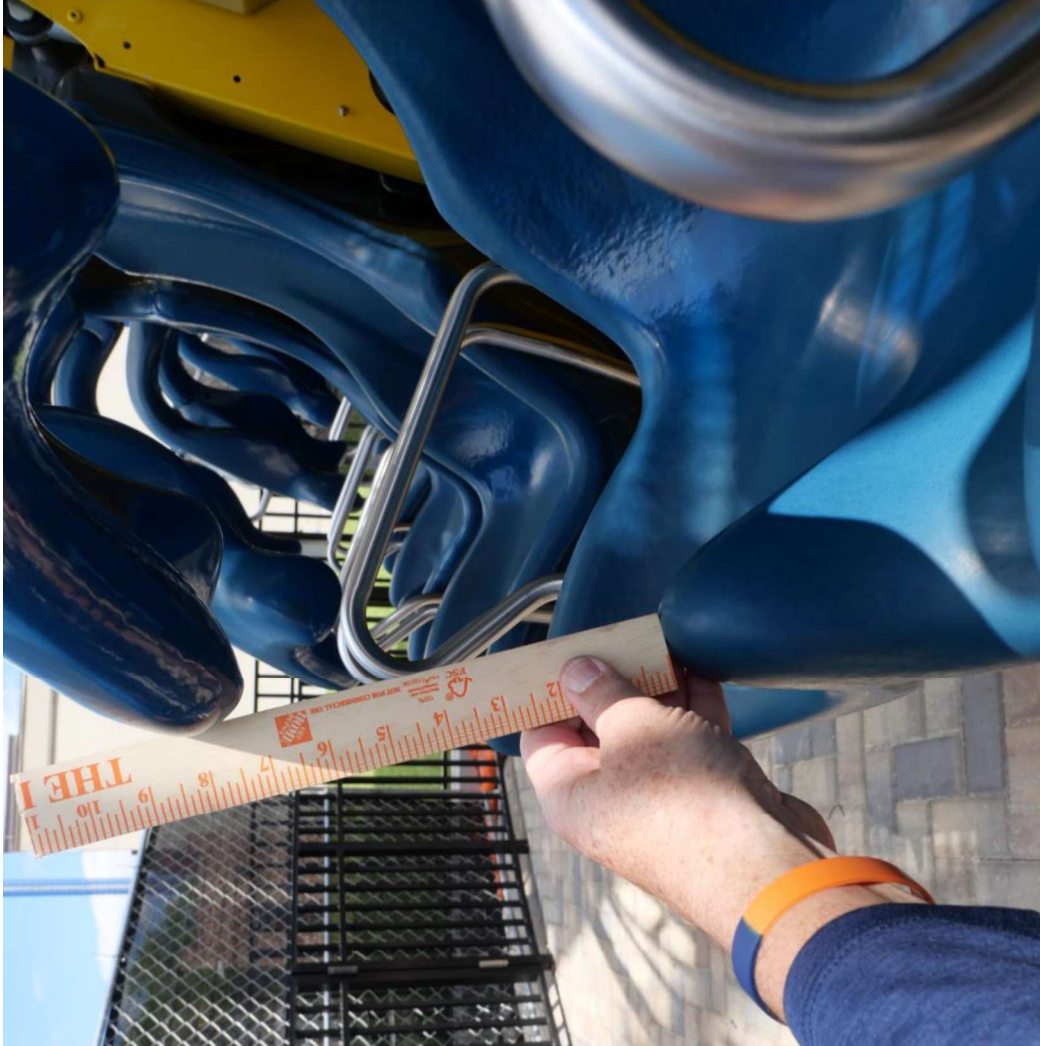
Photo 13

Testing to assess the “compliance” or give of the harness and harness padding during loading was performed. The restraint opening could be expanded by approximately 3 inches when tested up to about 250 lbs. of opening force. In other words, the effective restraint opening will expand by several inches when forced. Photographs 13 and 14 show the measurement process and compliance of the seat and harness.
